Approved For Release 2003/03/04: CIA-RDP78T05161A00/12,00010021-3 25X1 MAGERY ALYSIS IVISION PHOIOGRAPHIC INTELLIGENCE REPORT STATUS OF NORTH VIETNAMESE RAILROADS

Report No. 10 CIA/PIR 75037

DATE Oct. 1966

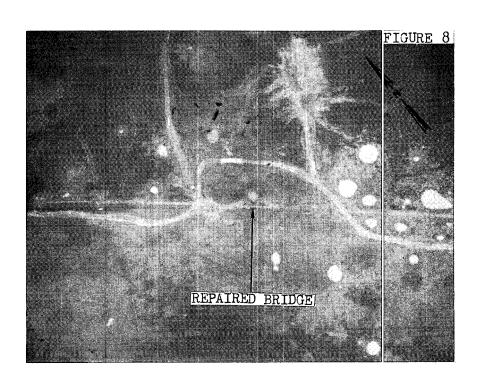
NAME: Trai Tran Xom RR Bridge

Photography revealed that the Trai Tran Xom Railroad Bridge has been repaired and 1s serviceable.

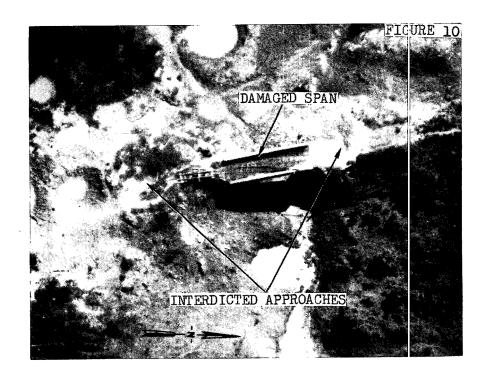
NAME: Hoa Duyot RR Bridge

Photography revealed that the Hoa Duyot Railroad Bridge remaings unserviceable partially damaged and both approaches interdicted.
